# THE ROLE OF SEEDING IN RECLAMATION OF DISTURBED SITES

DAVID POLSTER,  
POLSTER ENVIRONMENTAL SERVICES LTD.

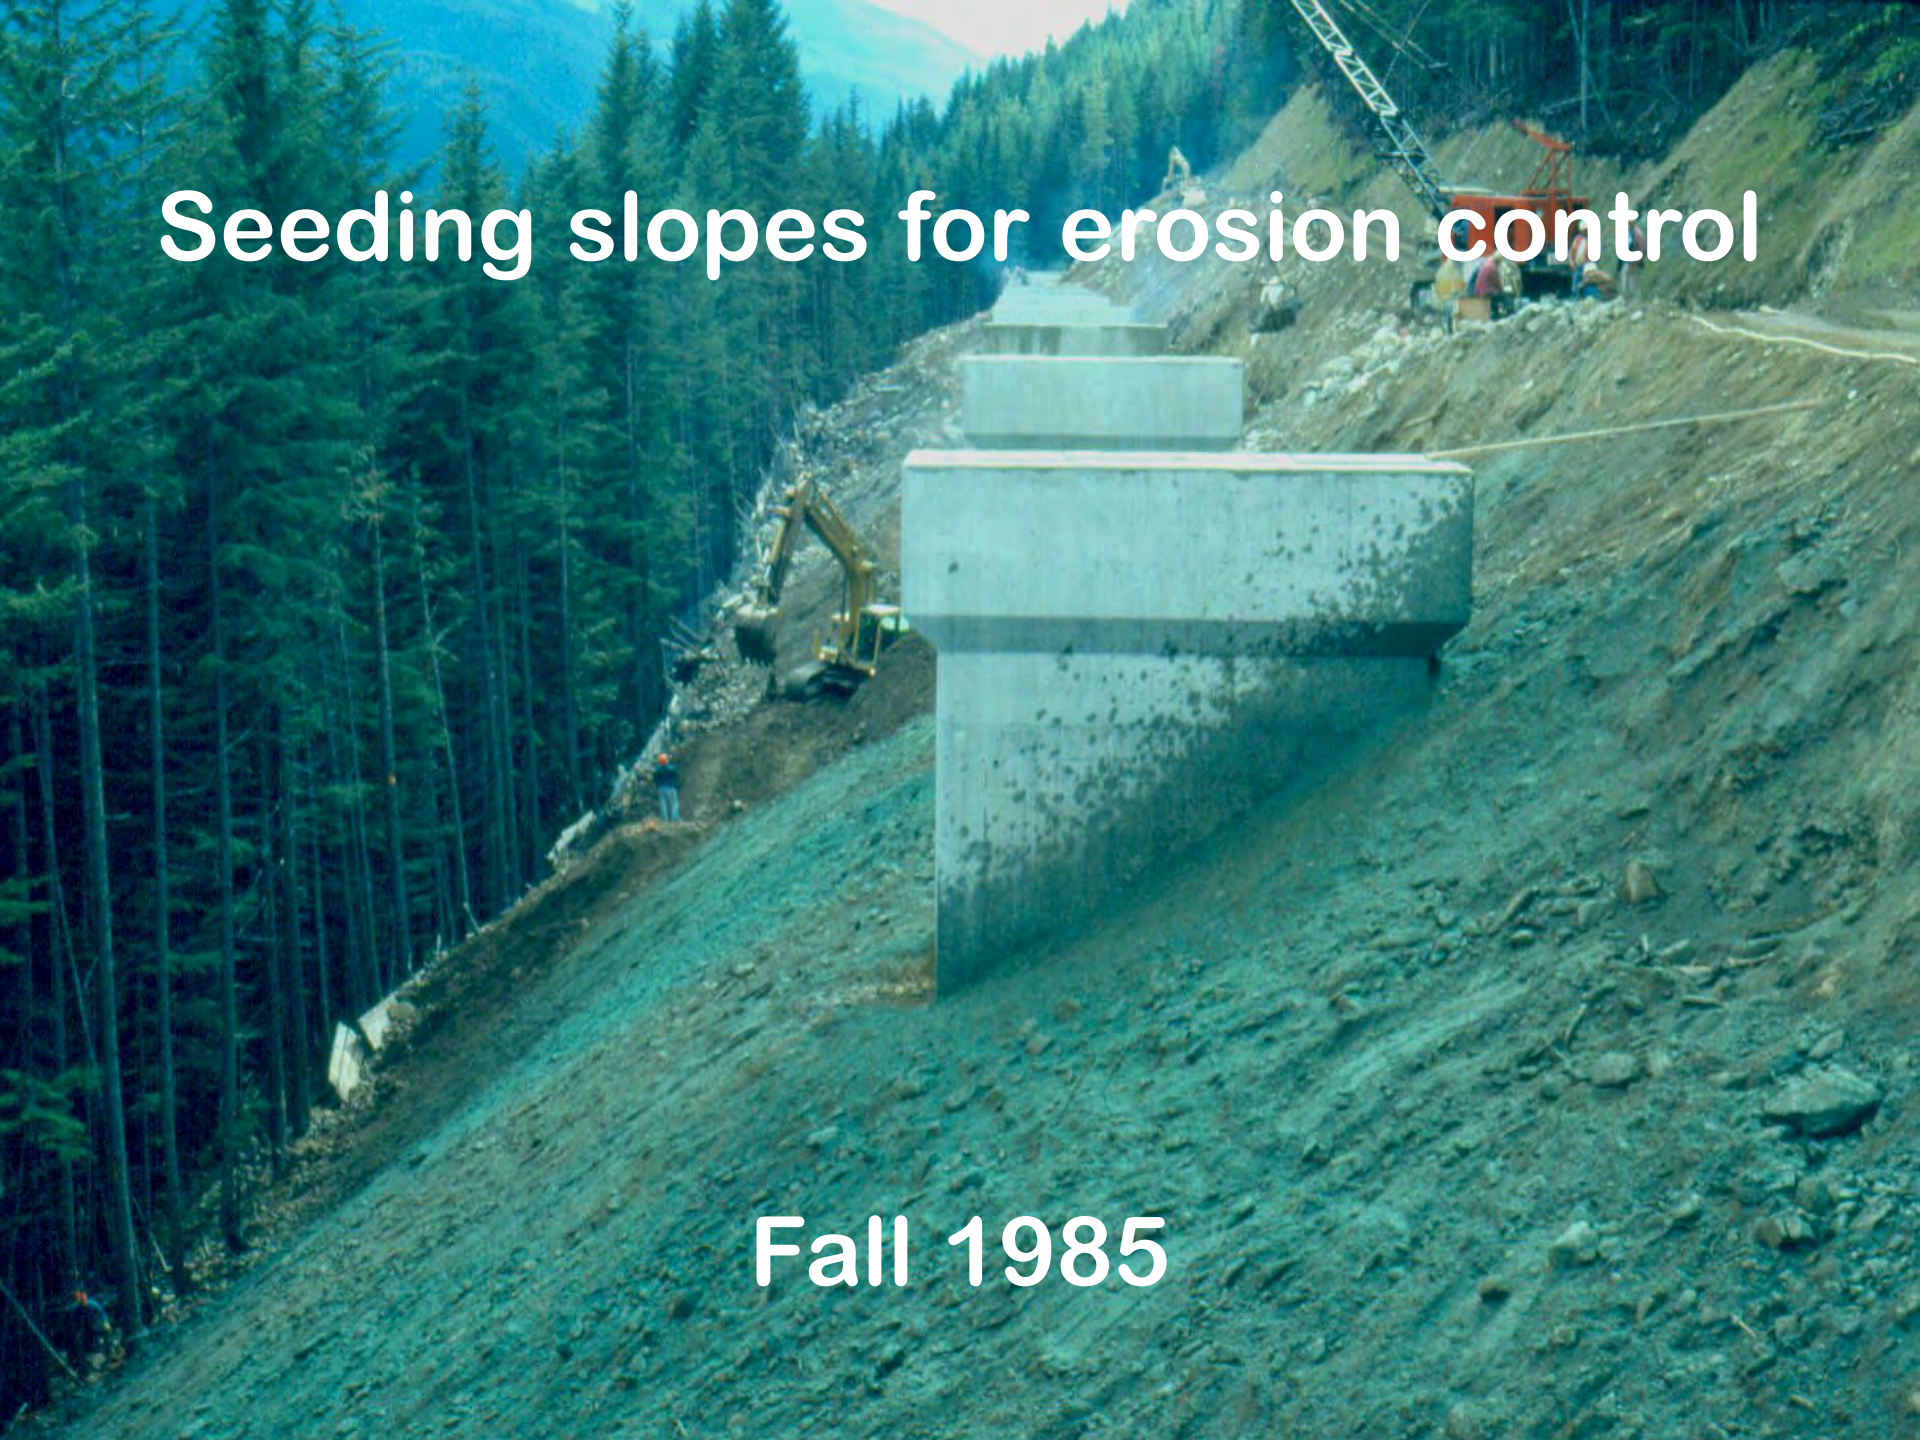
Seeding slopes for erosion control

Excellent cover of seeded species...

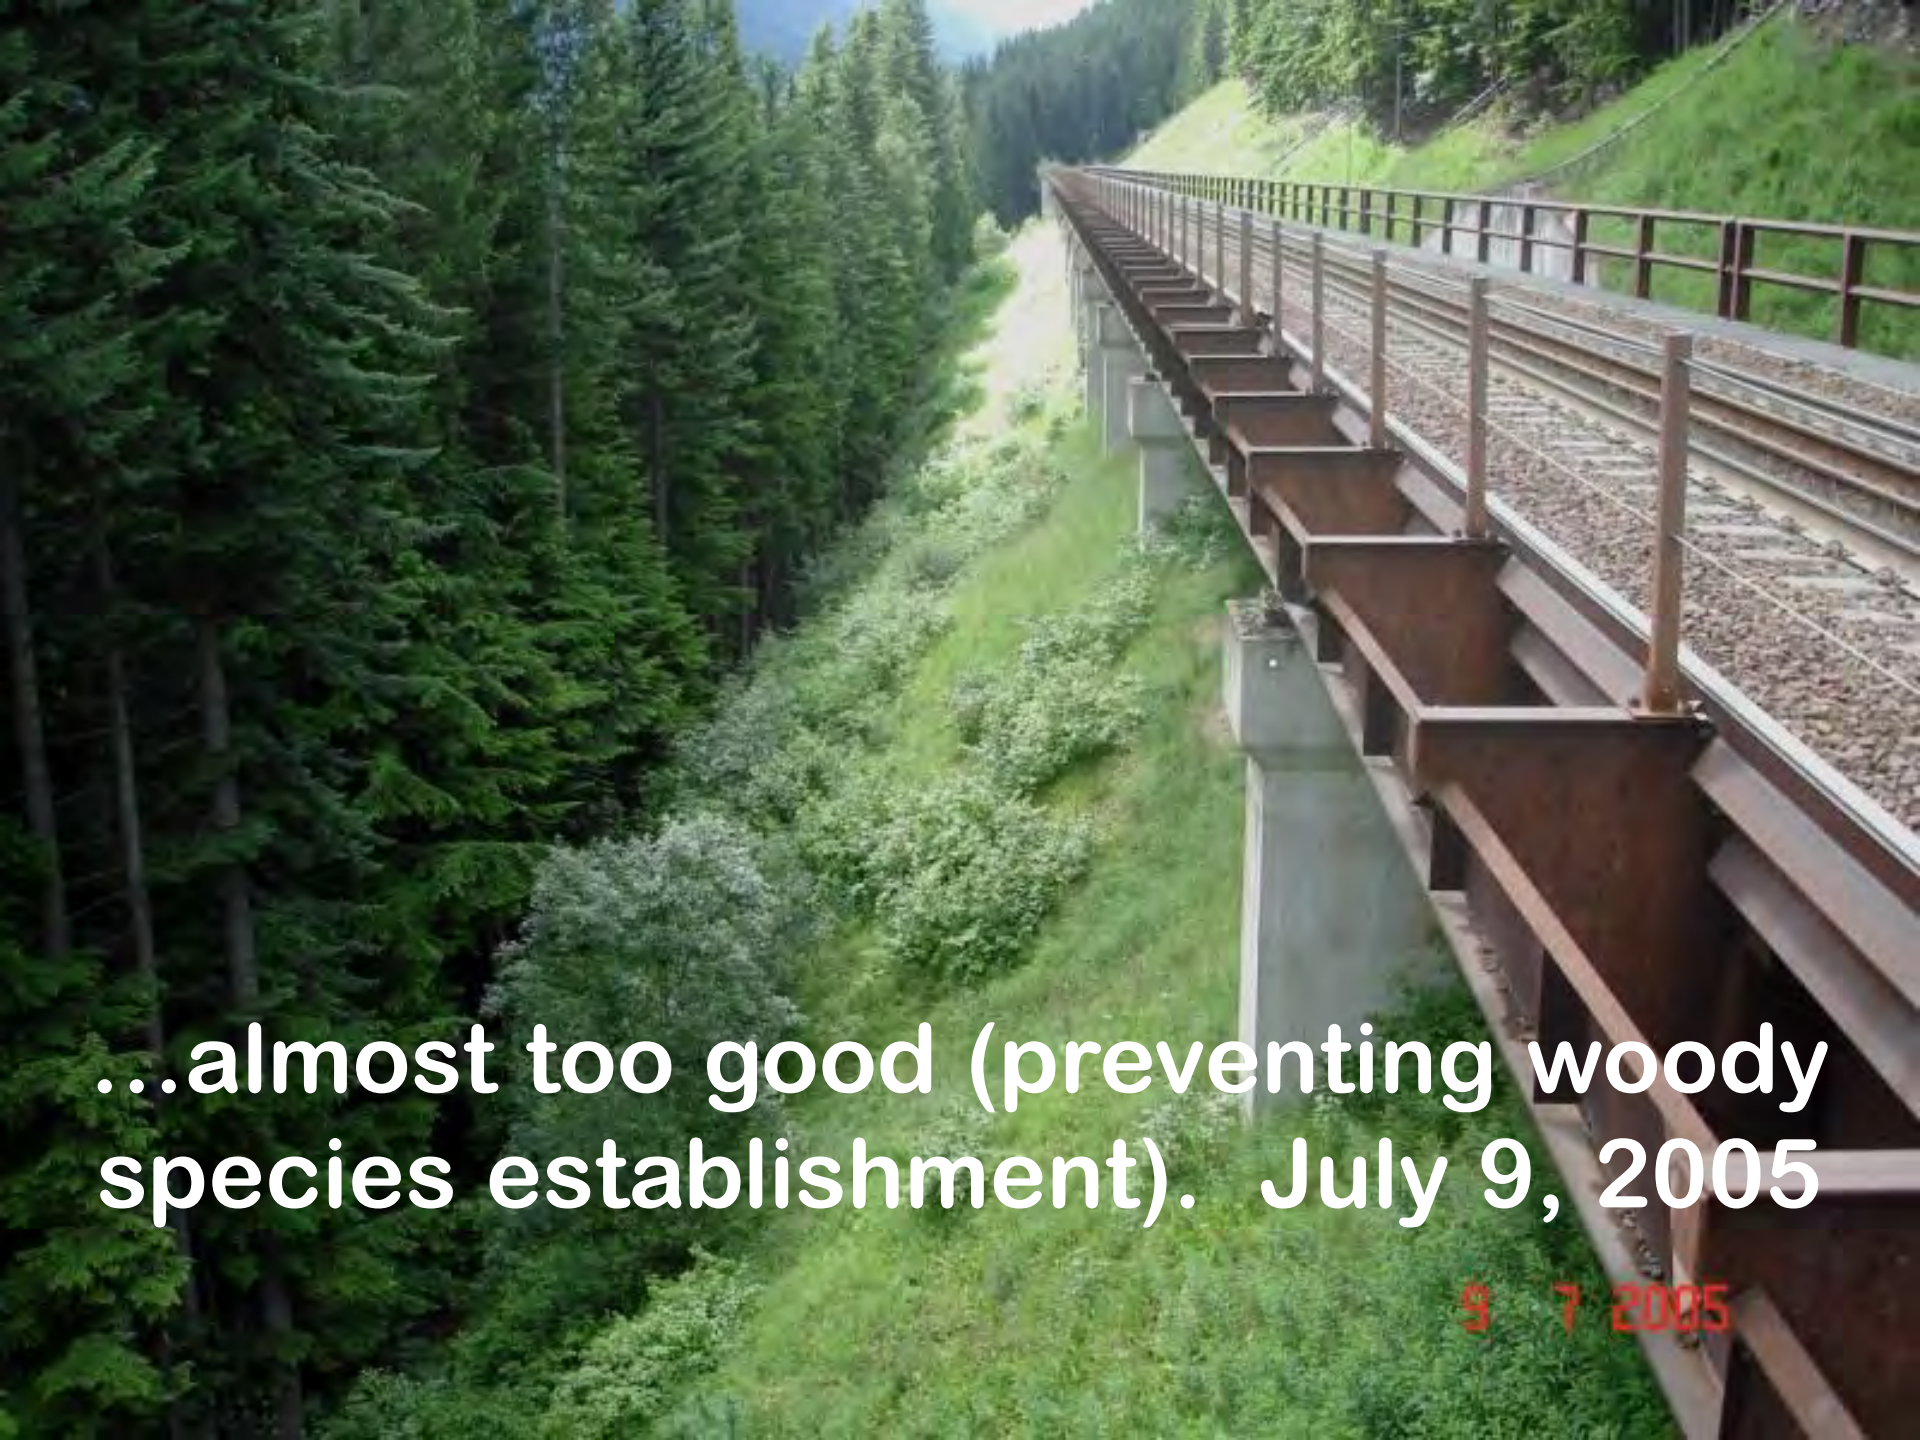
...almost too good (preventing woody species establishment). July 9, 2005

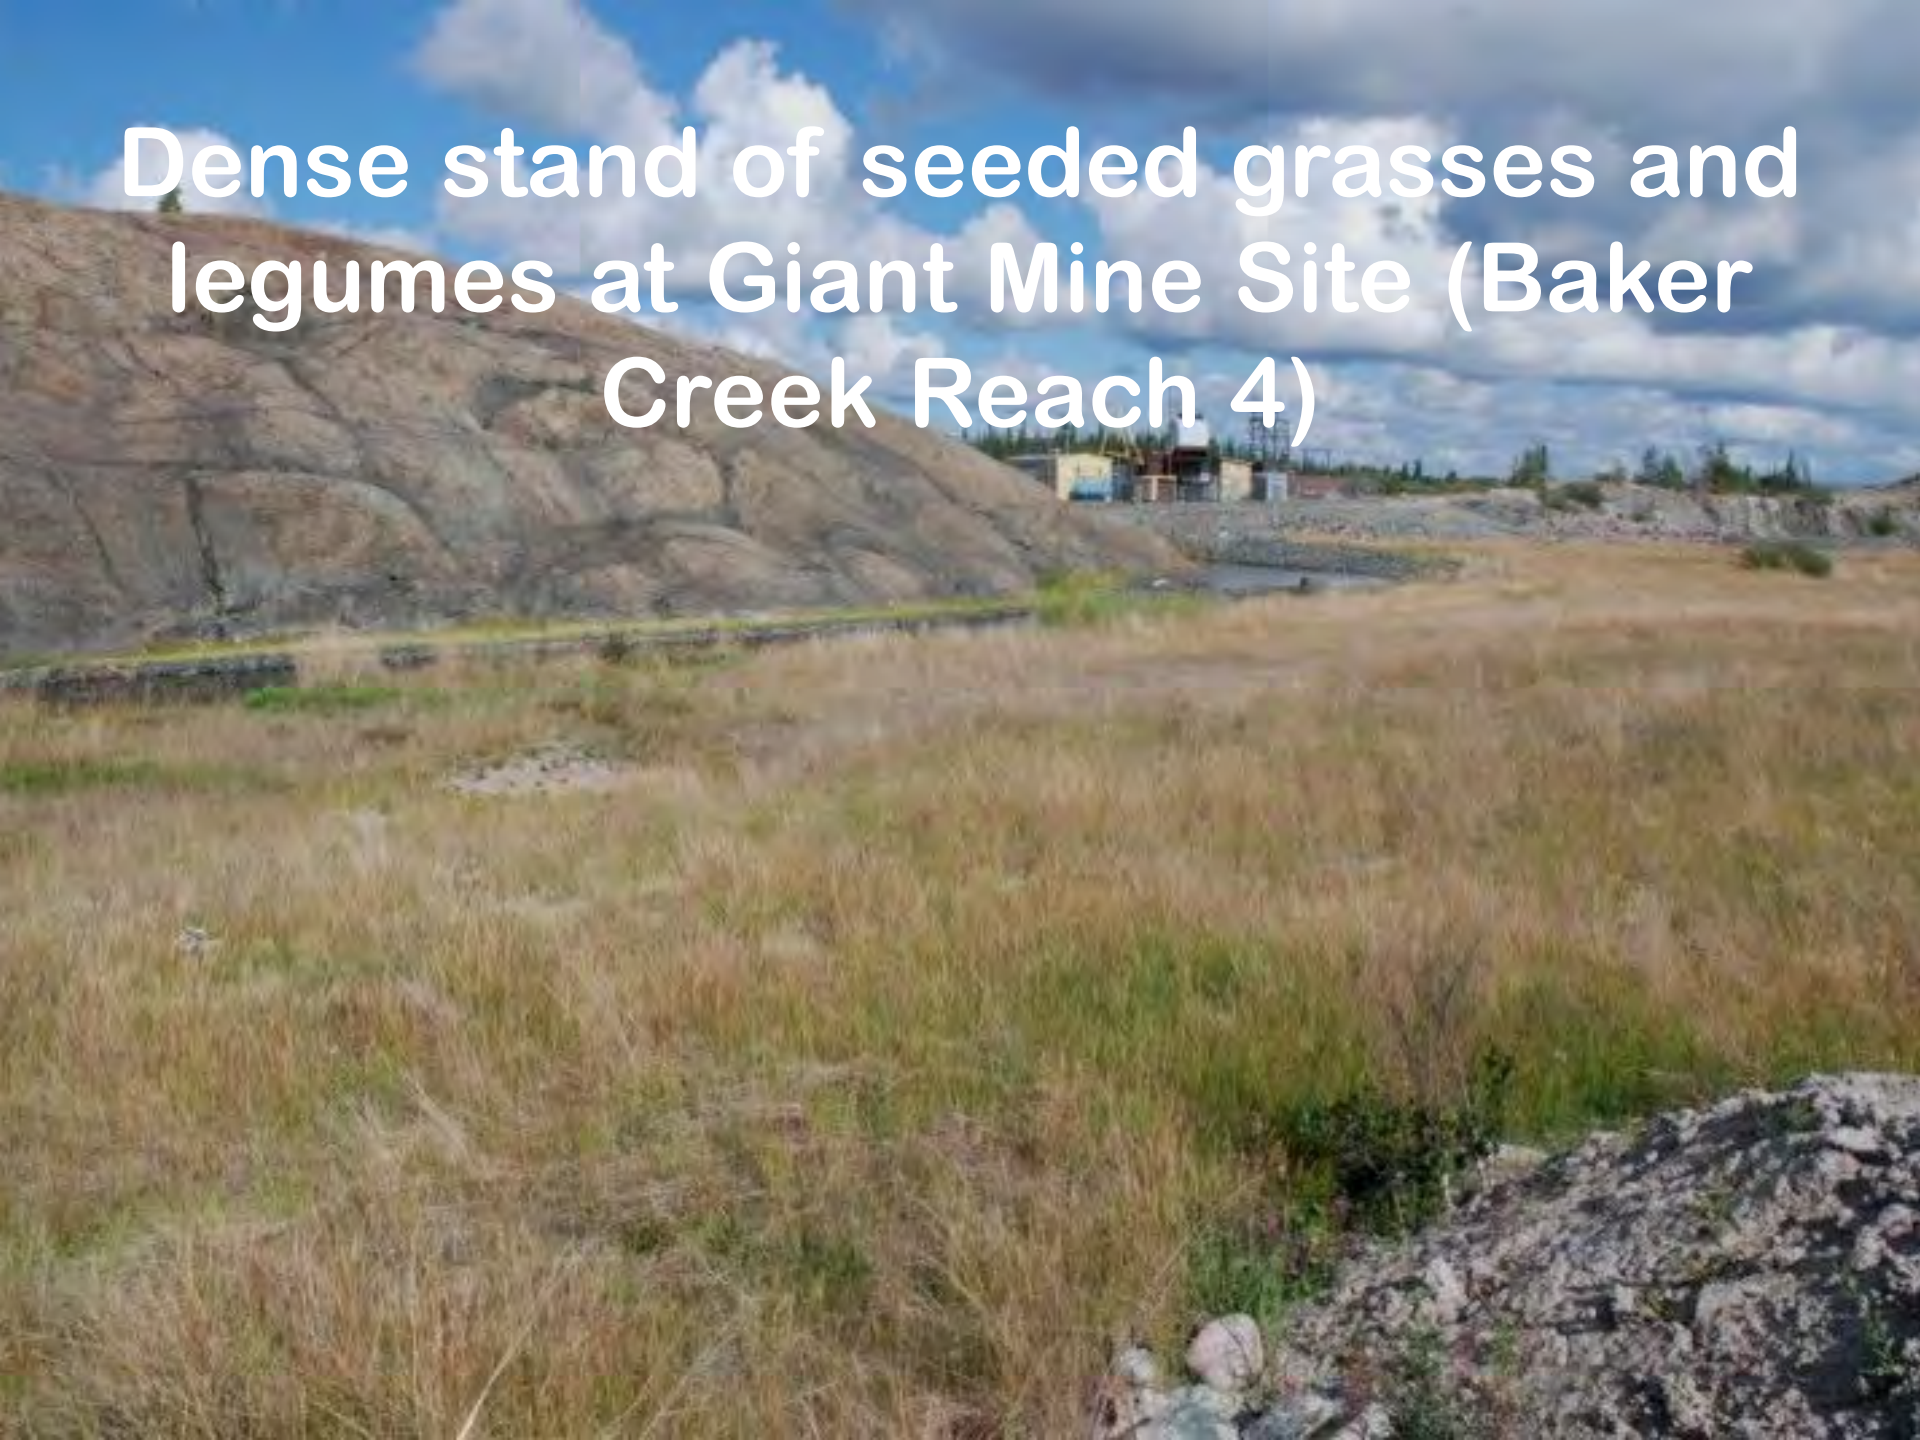
# Dense stand of seeded grasses and legumes at Giant Mine Site (Baker Creek Reach 4)

Poor spruce trying to make a living in a  
dense stand of seeded species (Baker  
Creek Reach 4)

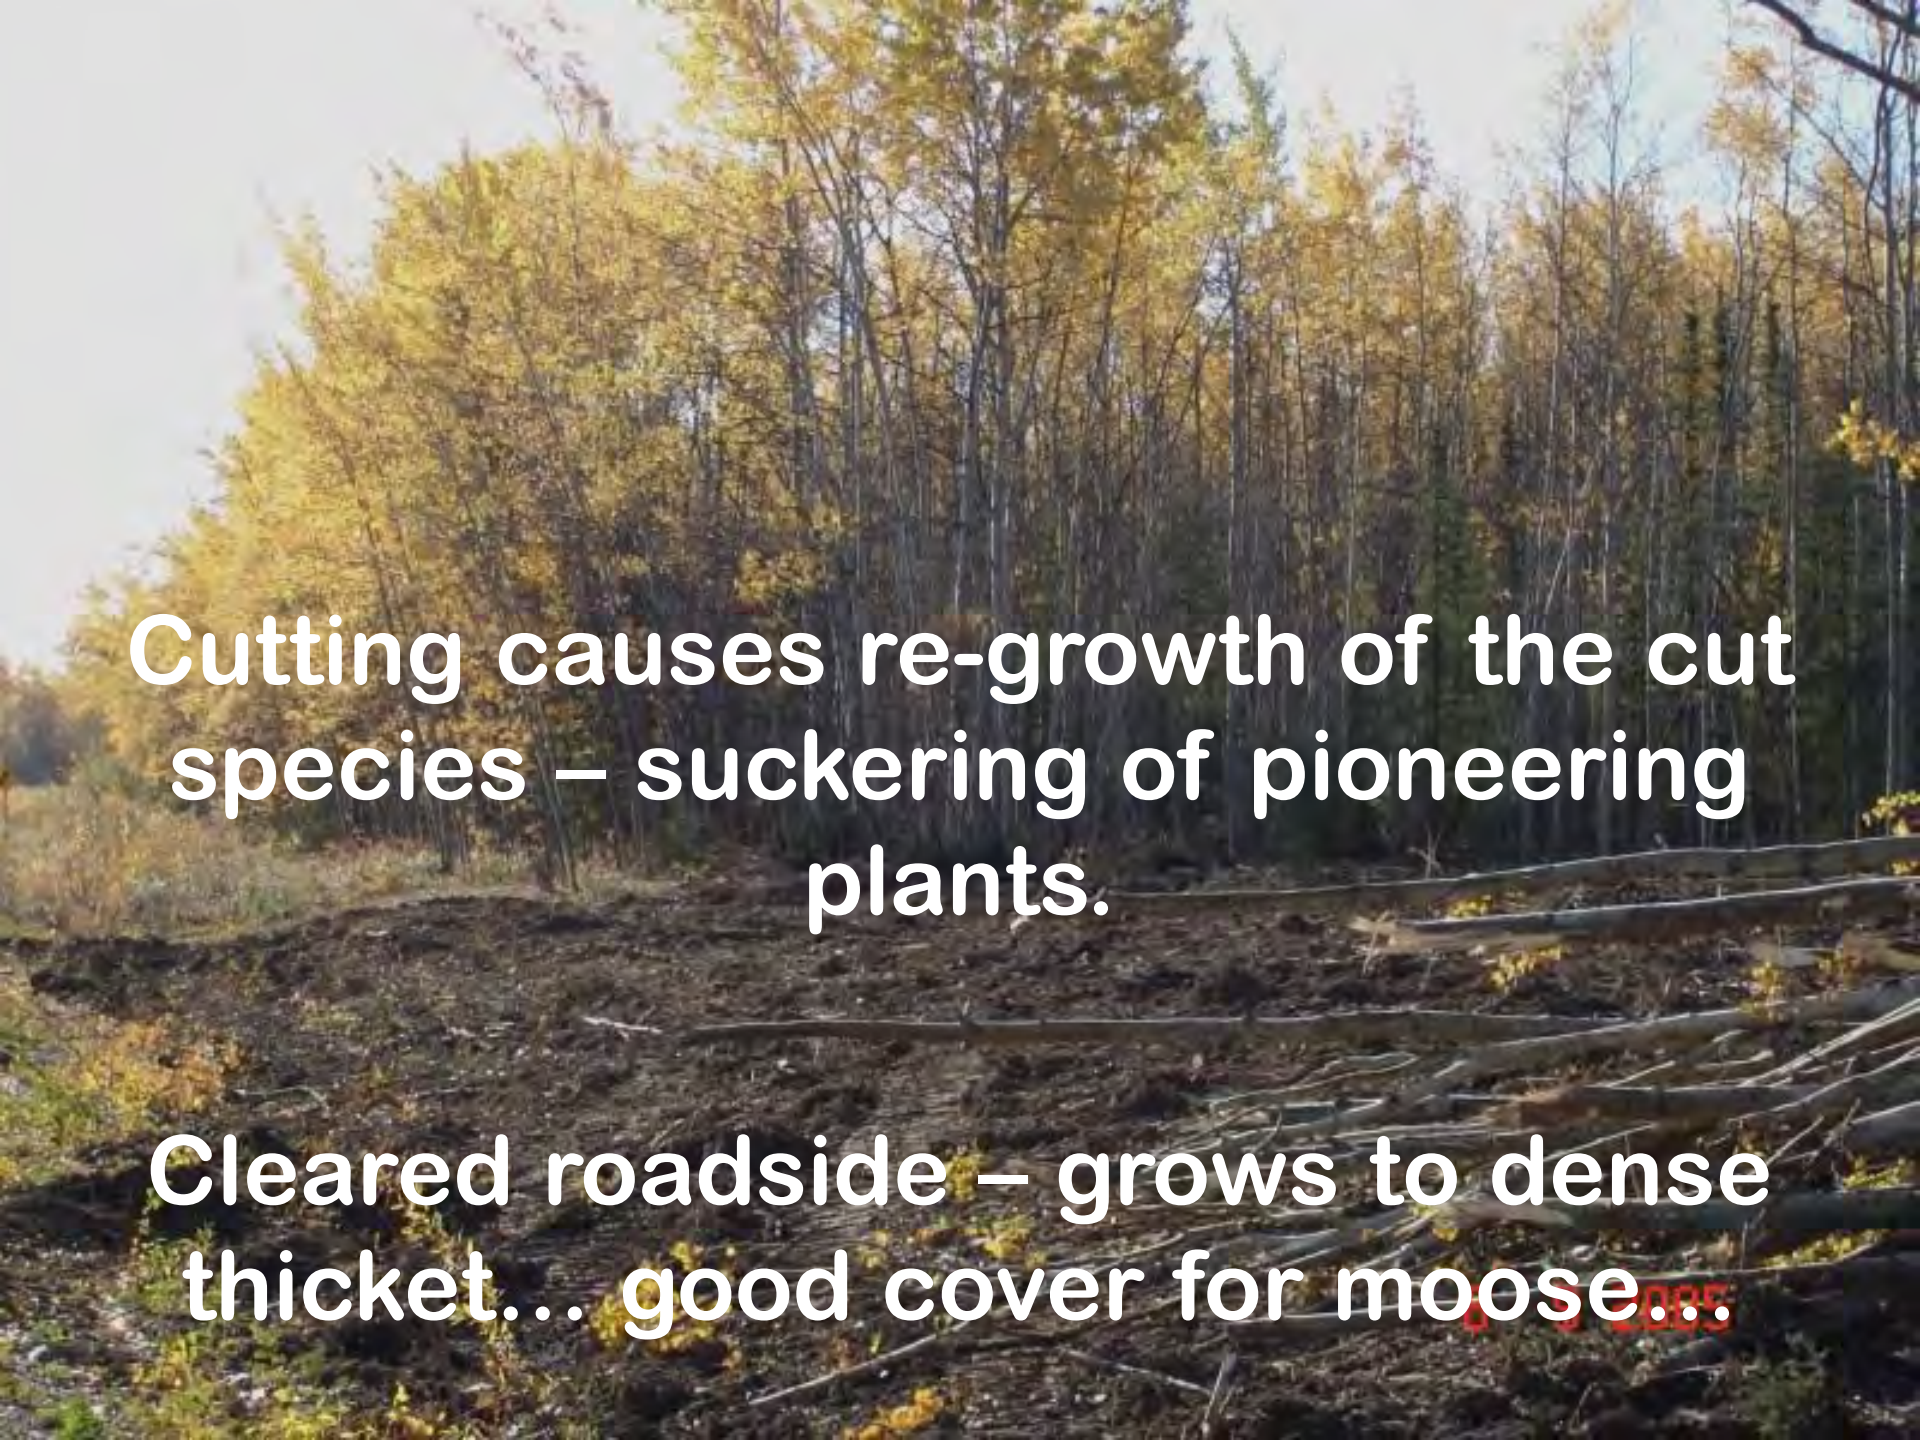
Cutting causes re-growth of the cut species – suckering of pioneering plants.

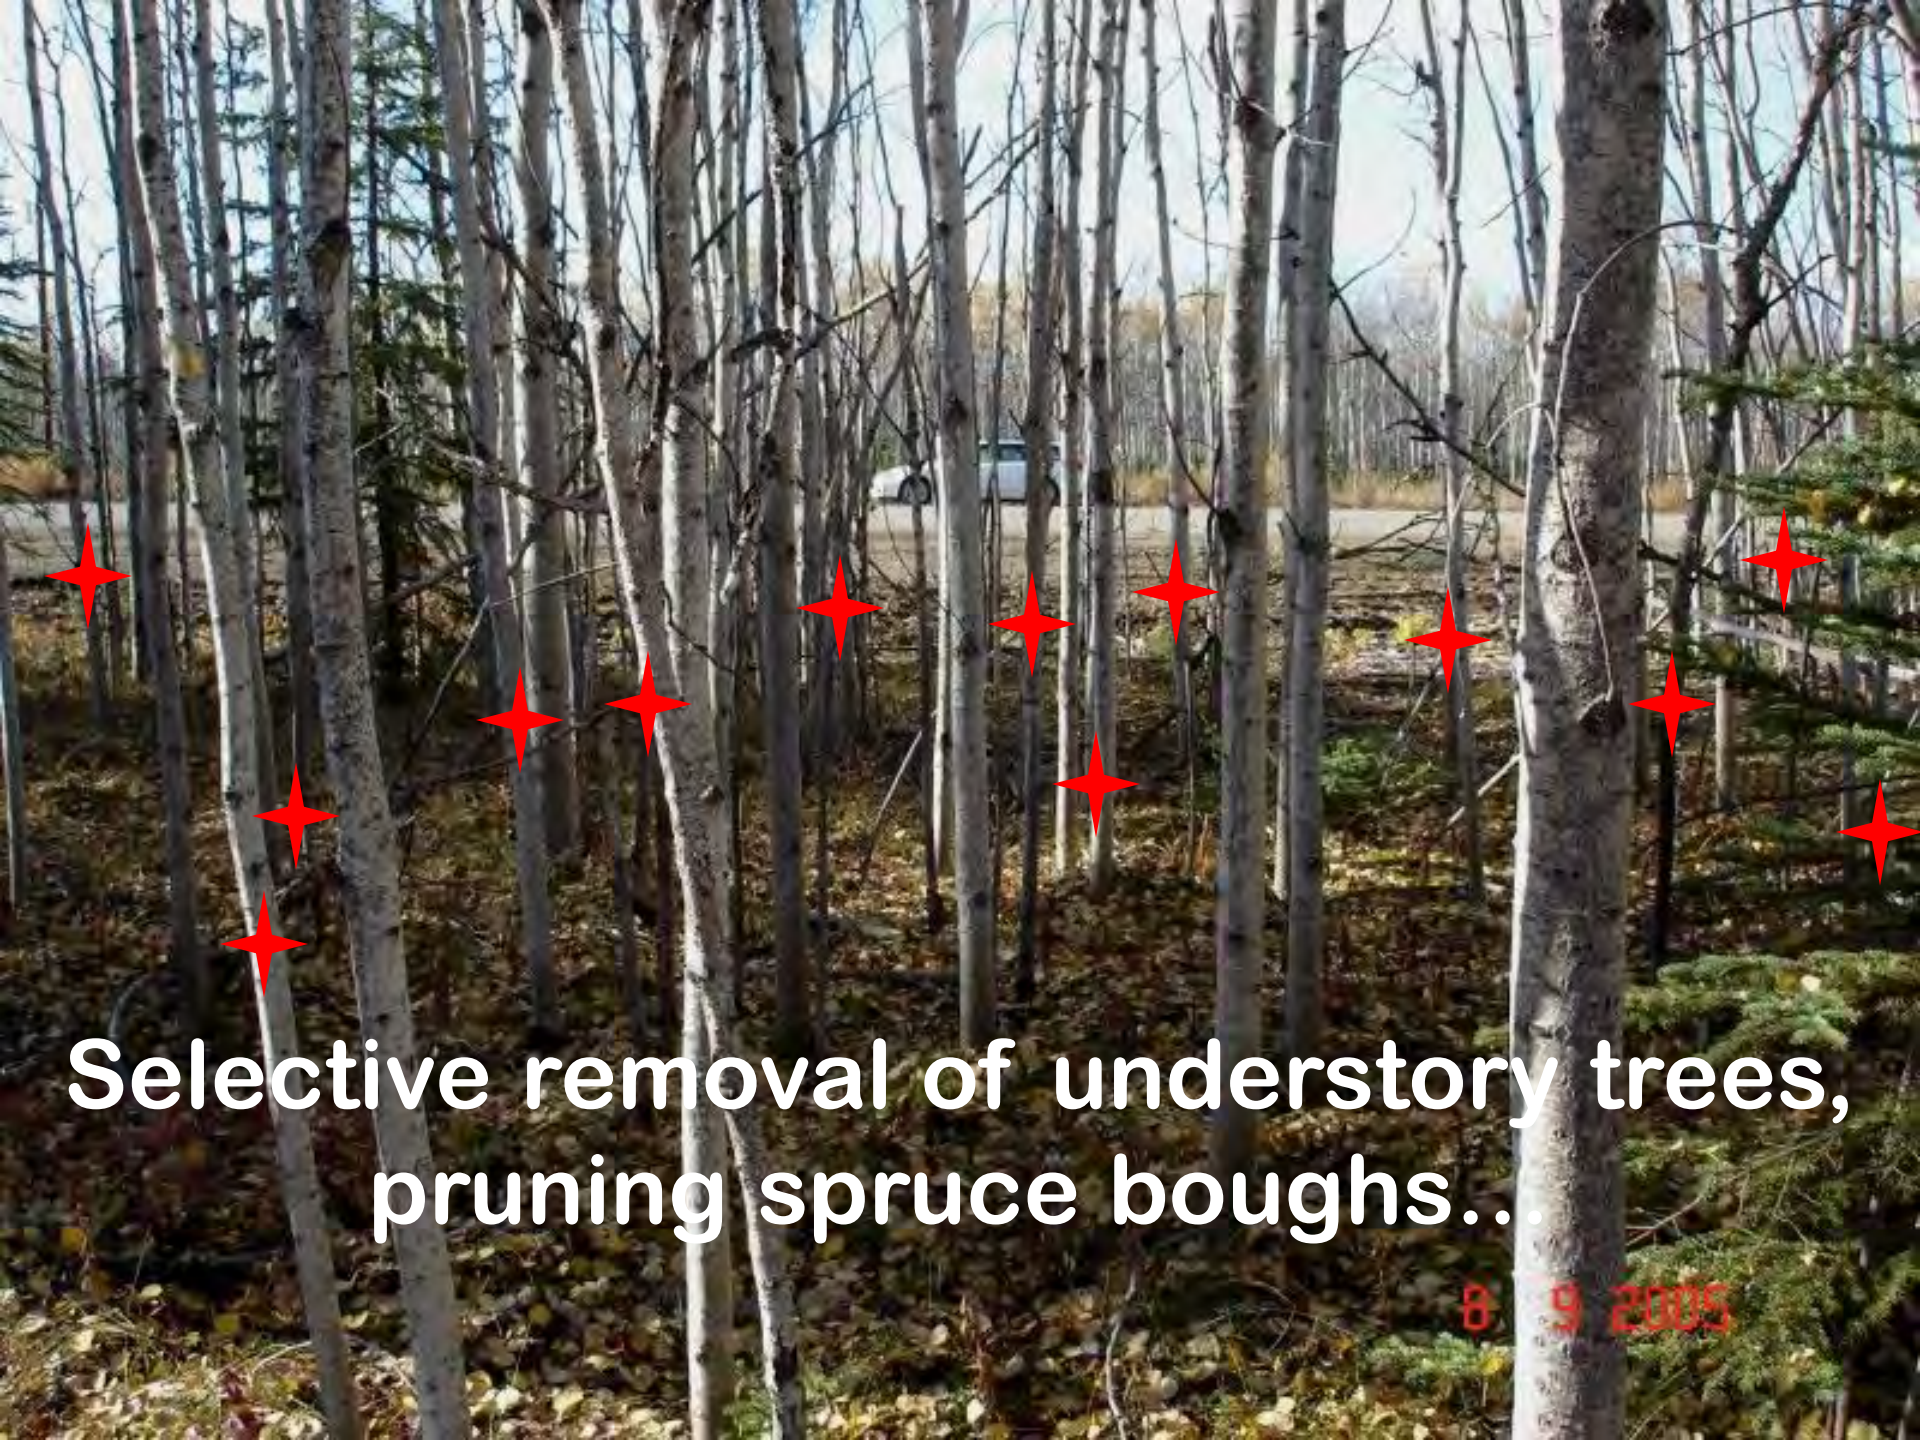
Selective removal of understory trees,  
pruning spruce boughs...

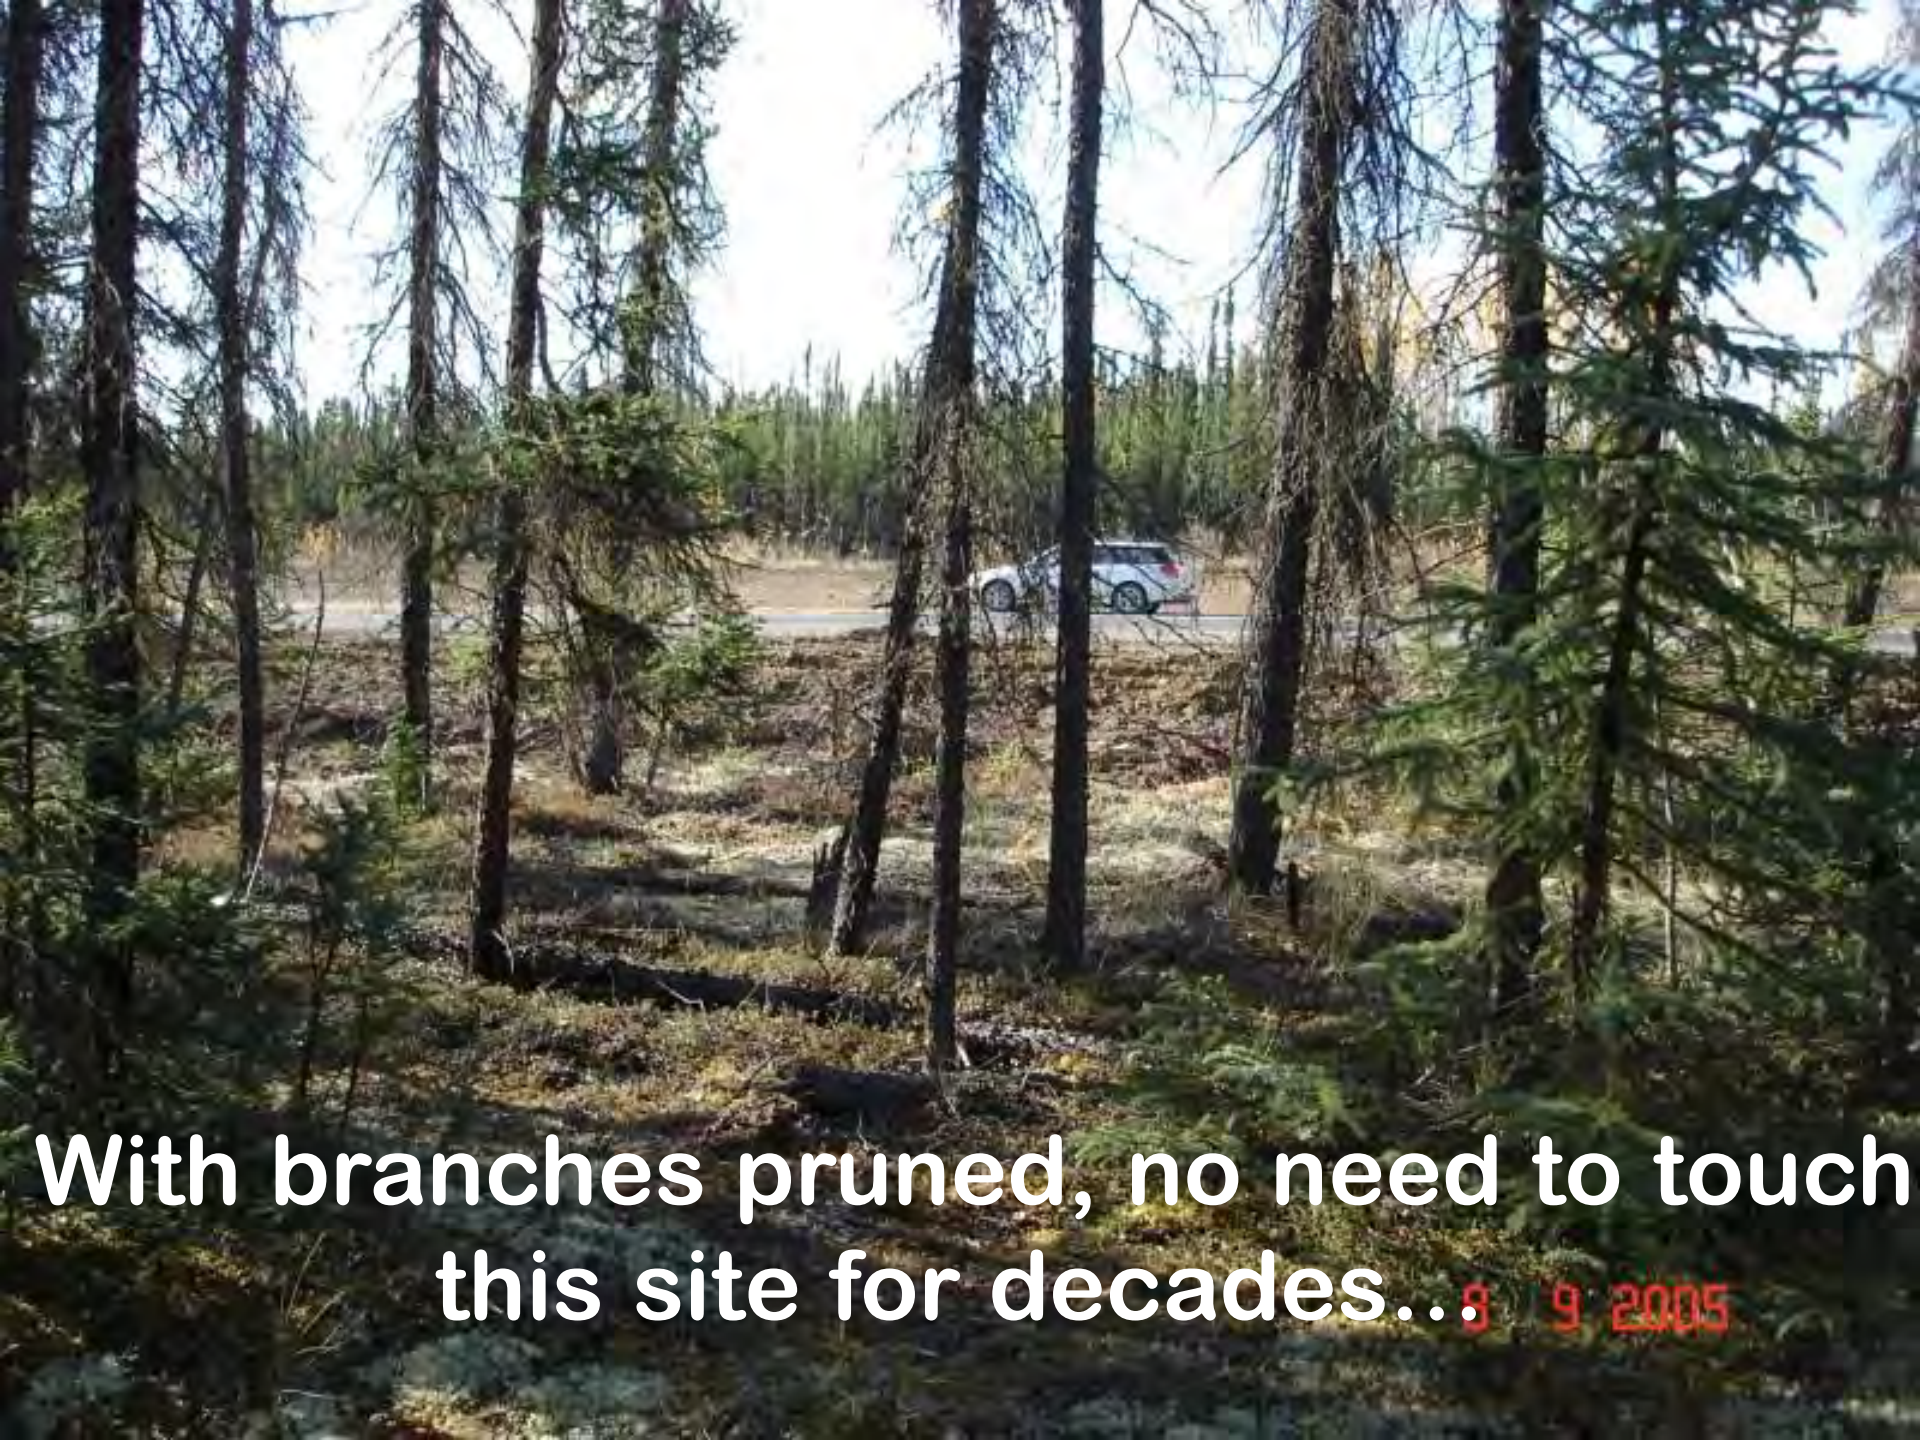
With branches pruned, no need to touch  
this site for decades..8 9 2005

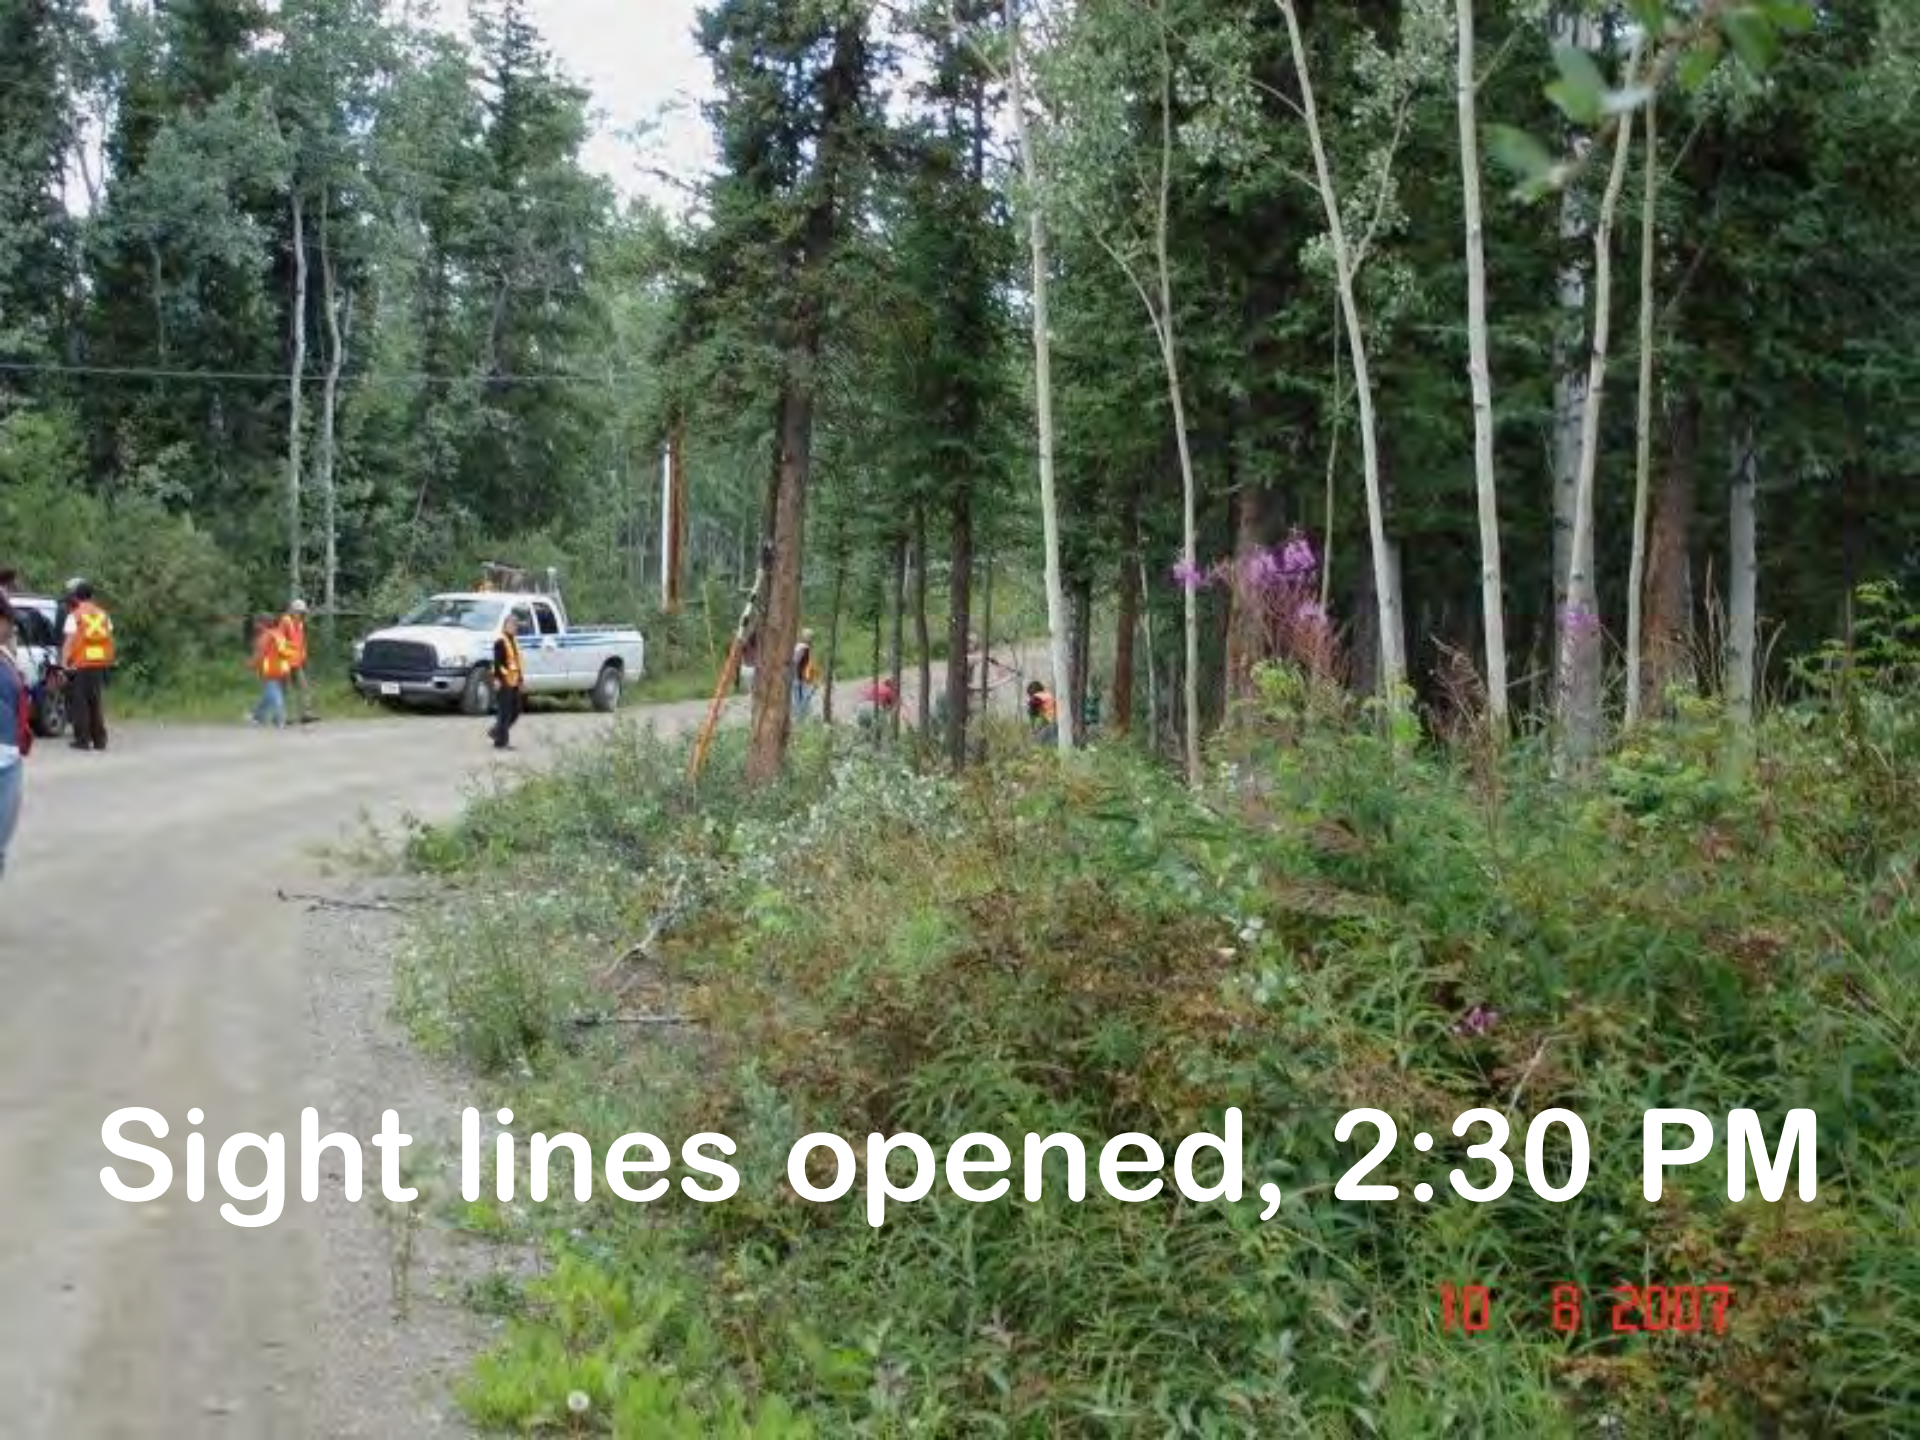
Sight lines opened, 2:30 PM

Pruning branches opens the sightlines  
without opening the site to early  
successional species.

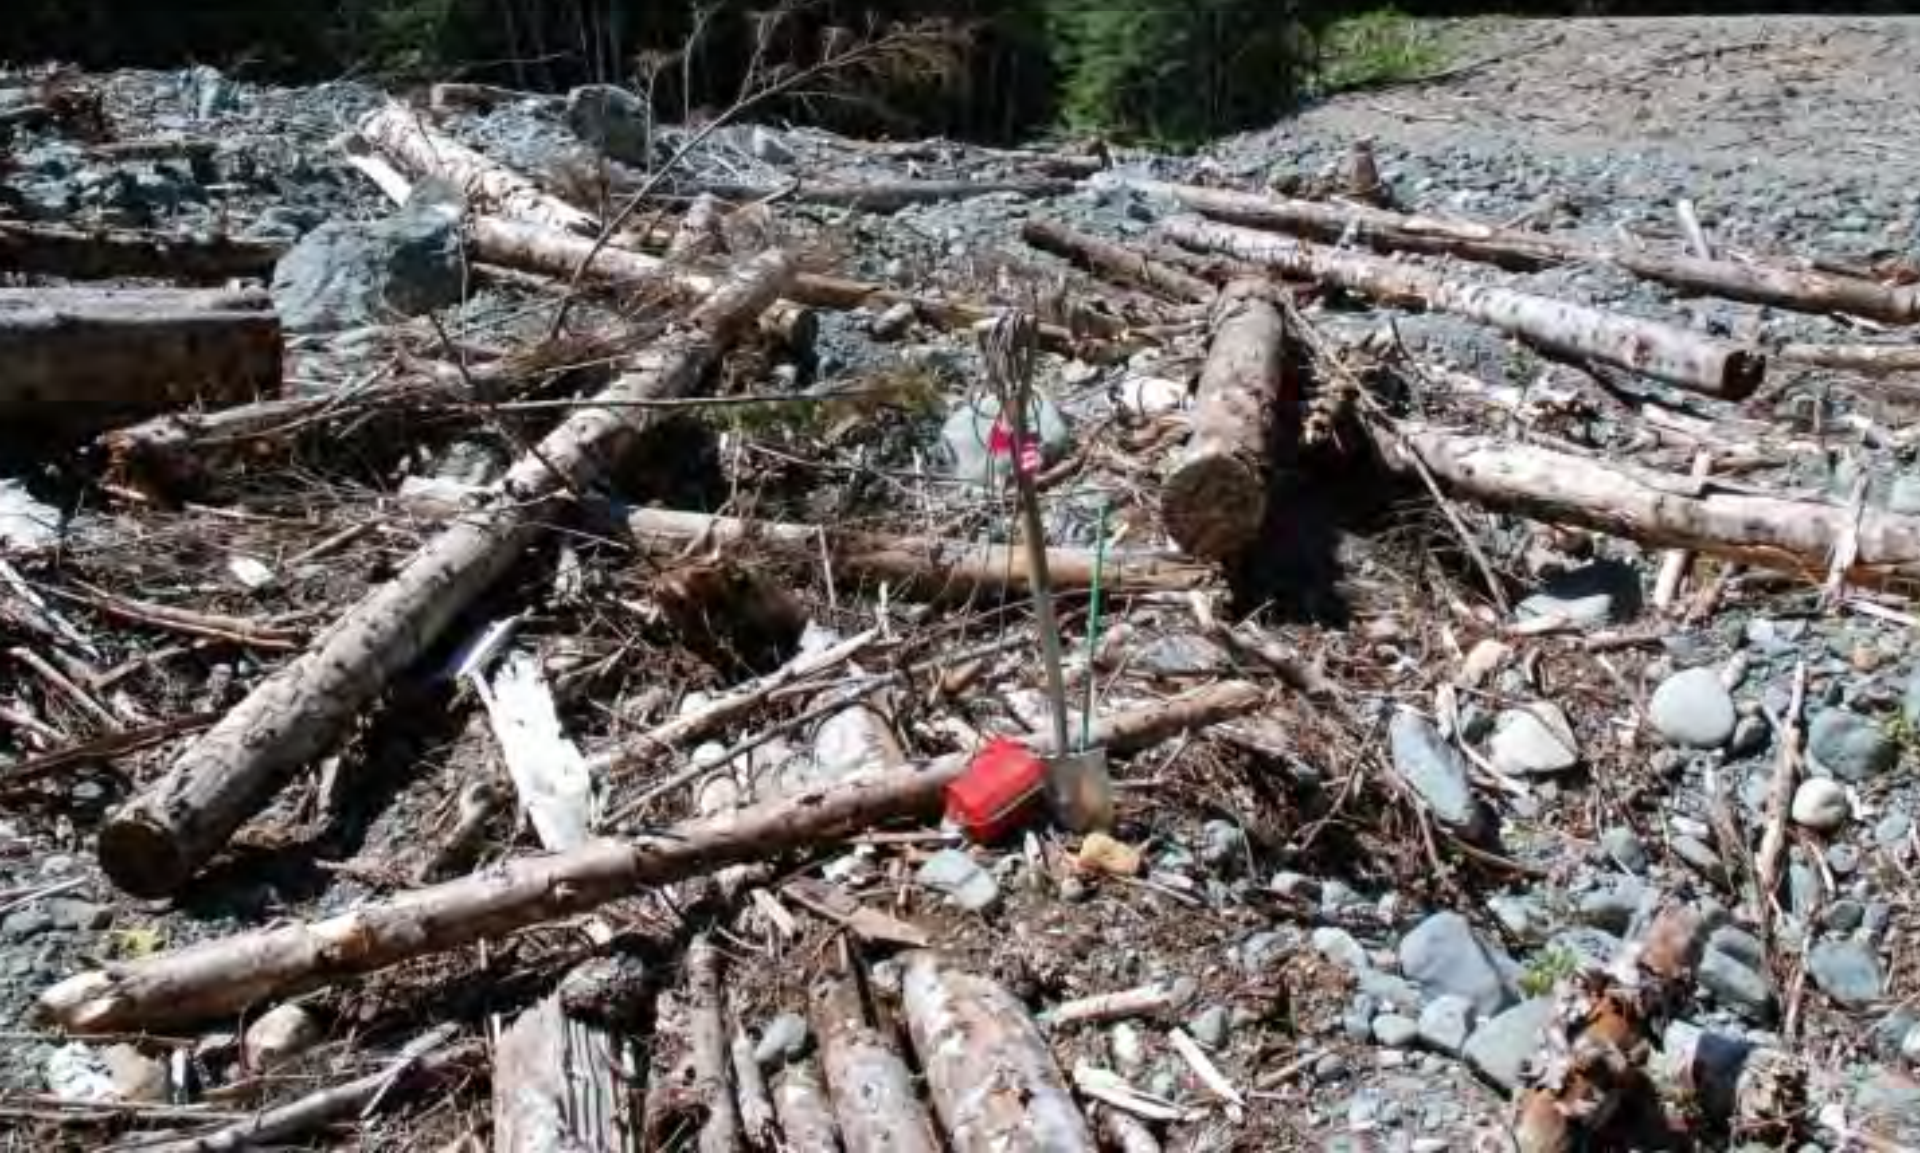
An average of 5,410 alder seedlings/hectare were found
