# THE ROLE OF SEEDING IN RECLAMATION OF DISTURBED SITES

DAVID POLSTER,  
POLSTER ENVIRONMENTAL SERVICES LTD.

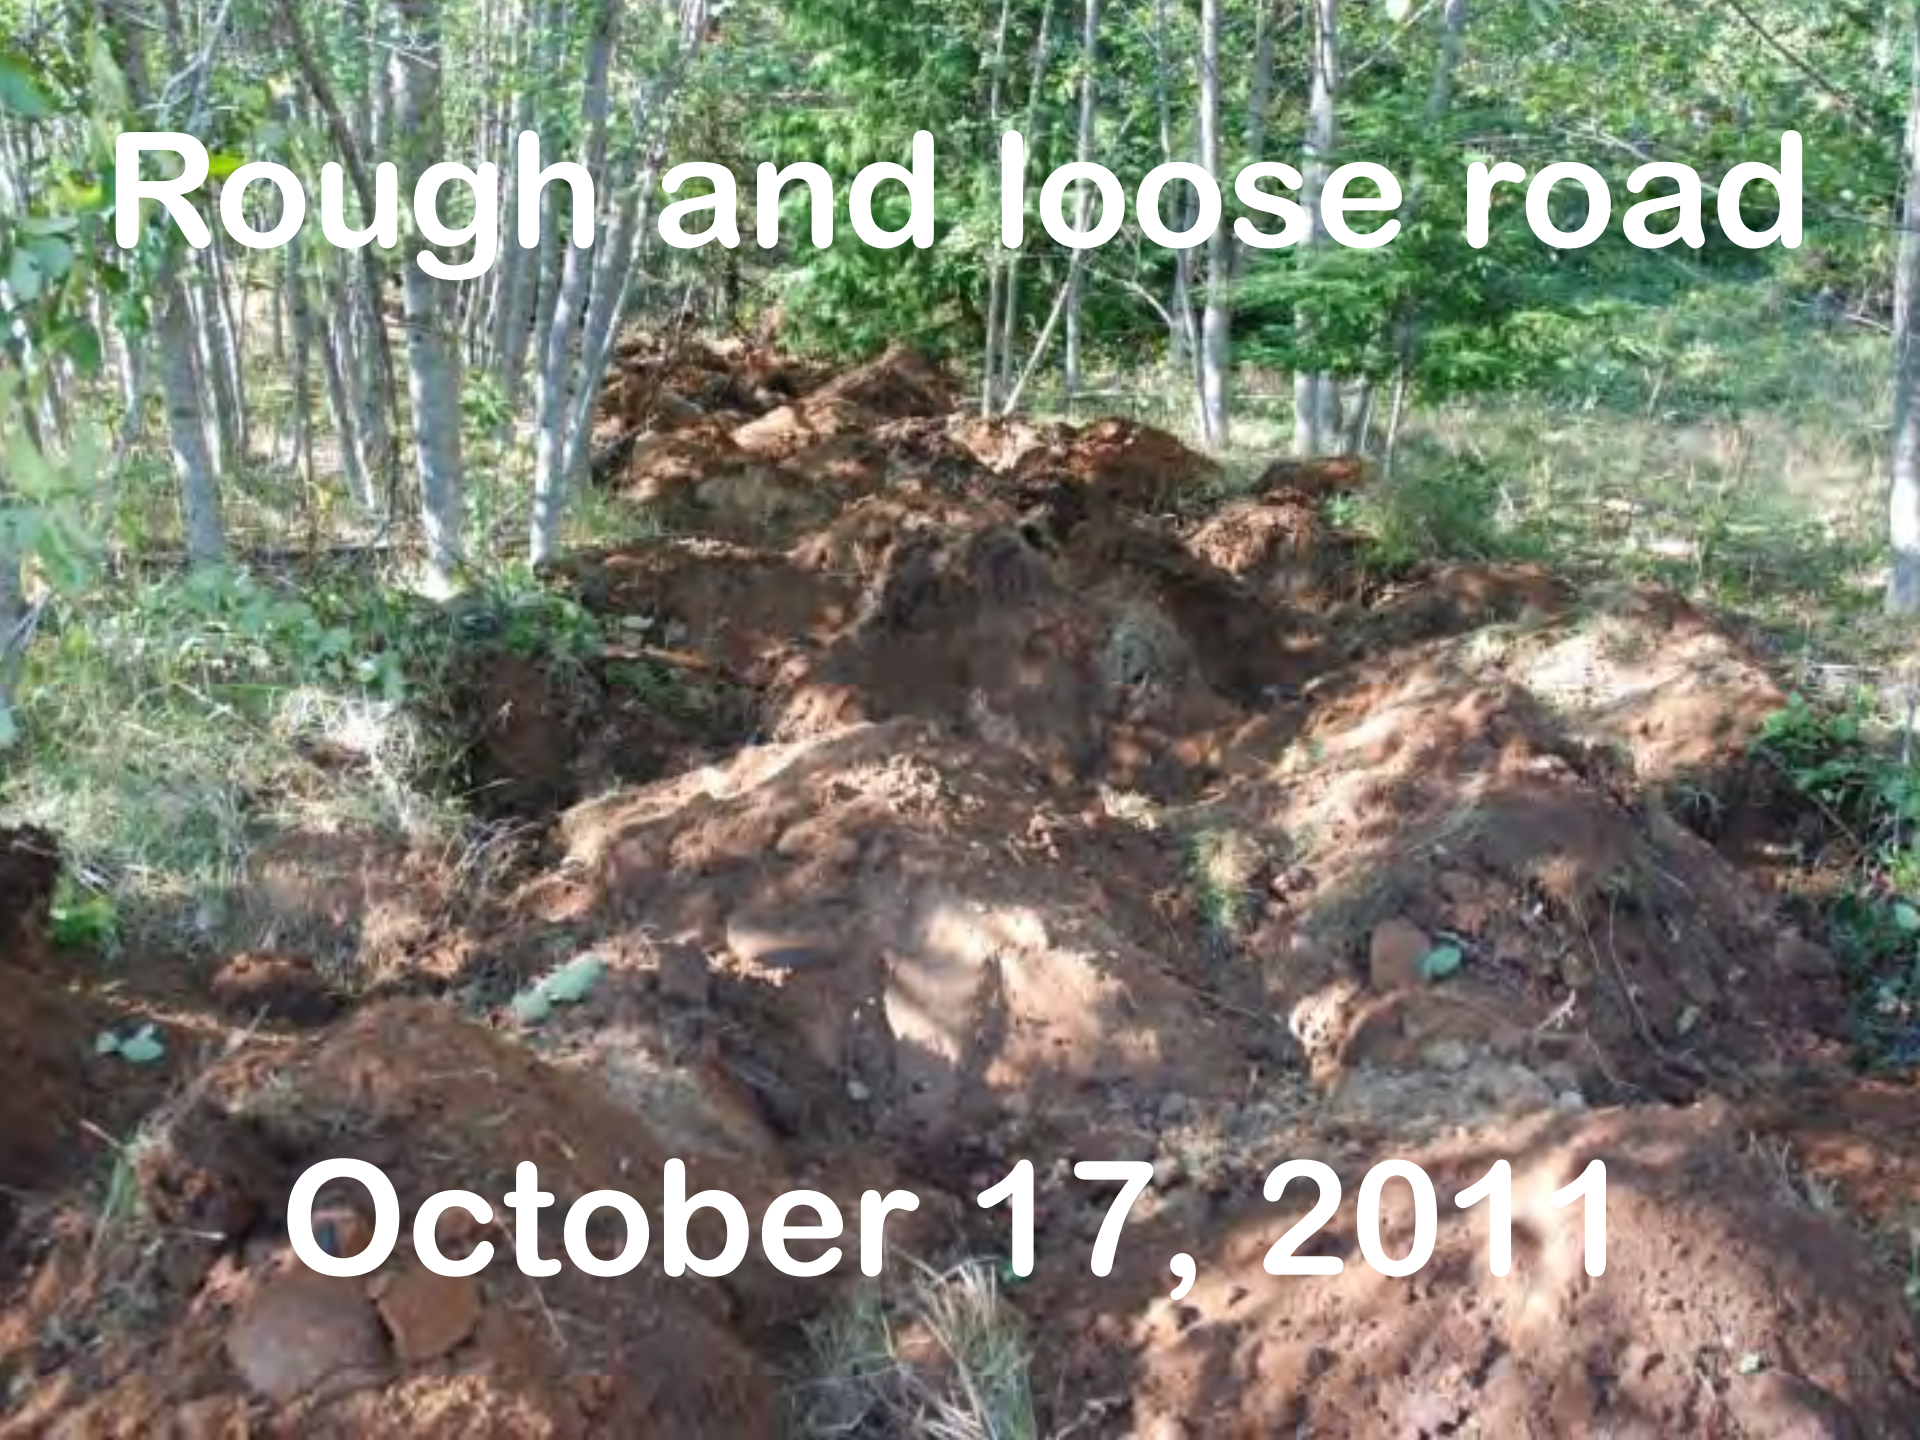
**Rough and loose road**

**October 17, 2011**

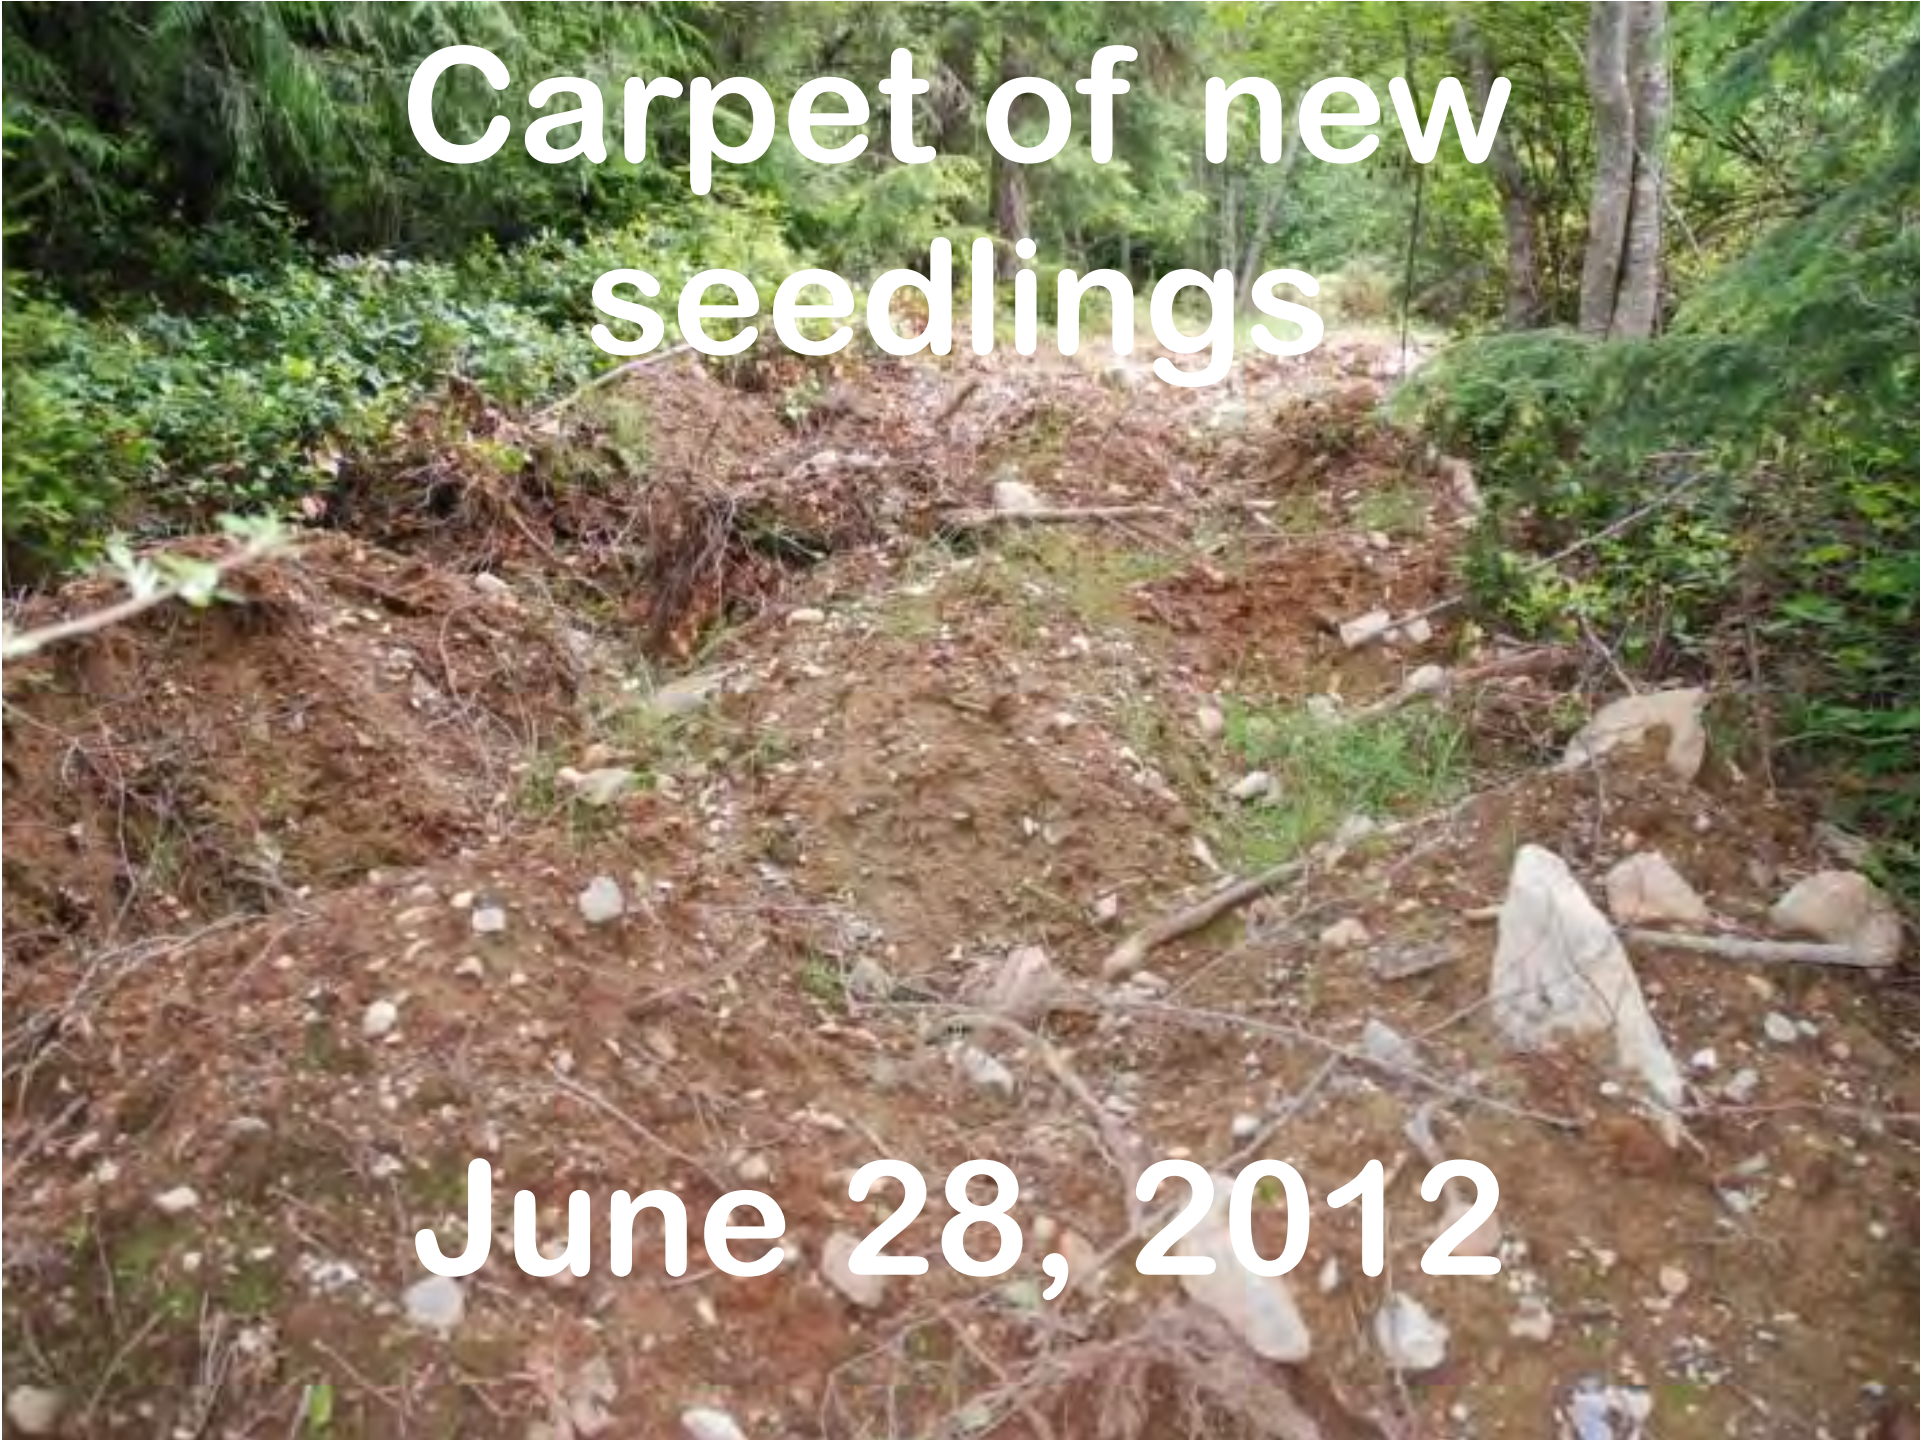
# Carpet of new seedlings

June 28, 2012
